Water Research Laboratory Eurobodalla Shire Council coastal hazard assessment

WRL Technical Report: Eurobodalla coastal hazard assessment (2017/09)

Clients: Eurobodalla Shire Council & NSW OEH

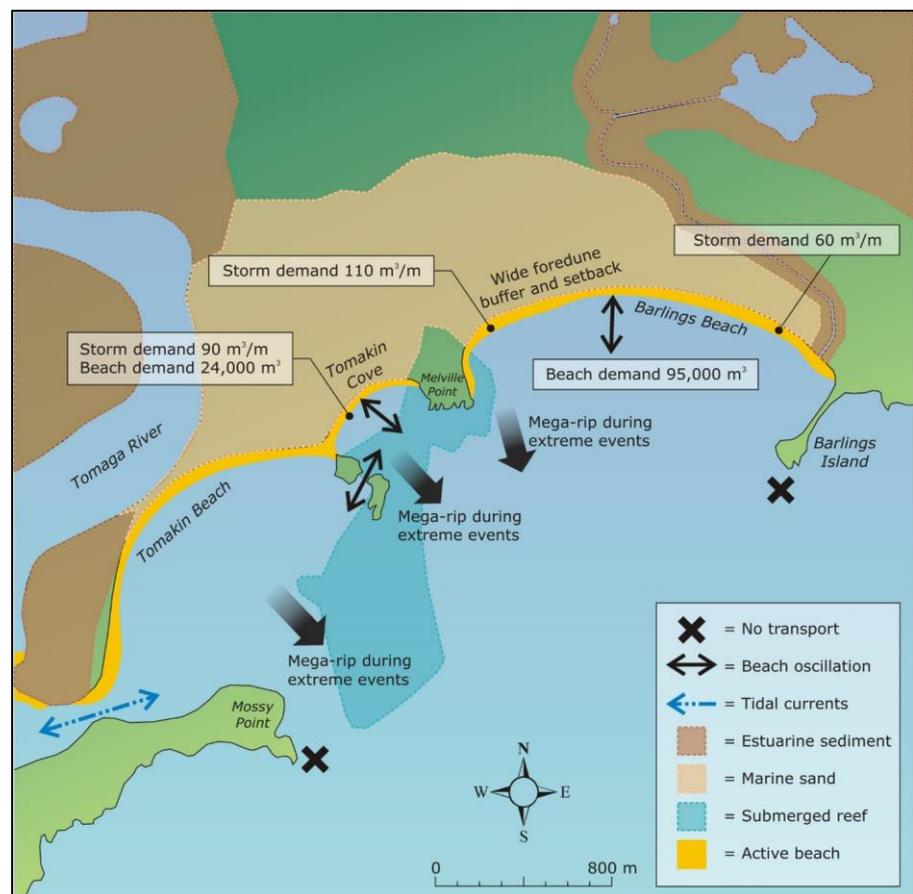
Figure 1: Conceptual model of sediment movement and storm demand at Barlings Beach and Tomakin Cove

- Conceptual sediment transport models (figure 1)
- Erosion/recession hazard maps
- Coastal inundation hazard maps

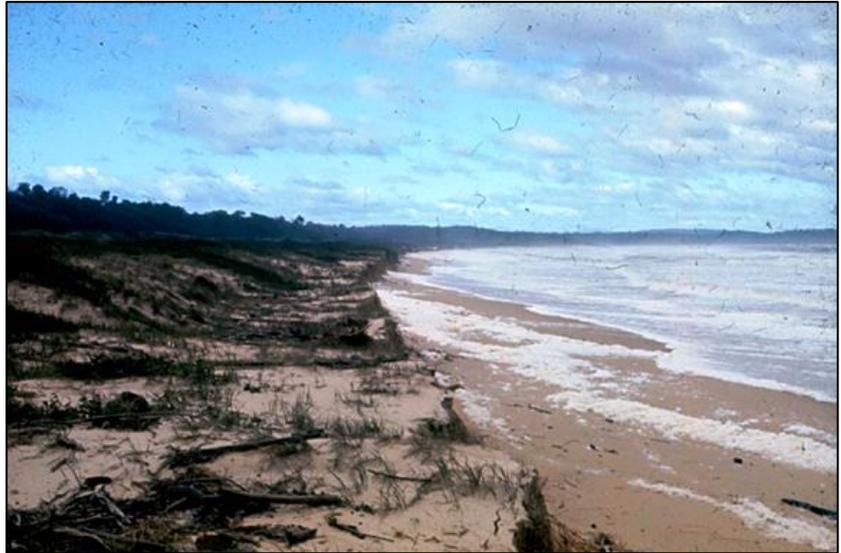
Figure 2: Bengello Beach survey area, 25 May 1974 (source: McLean et al., 2010)

The numerical model was calibrated against survey measurements of the erosion event of record, the May-June 1974 storm sequence, at the nearby Bengello Beach (just north of Moruya airport, figure 2).

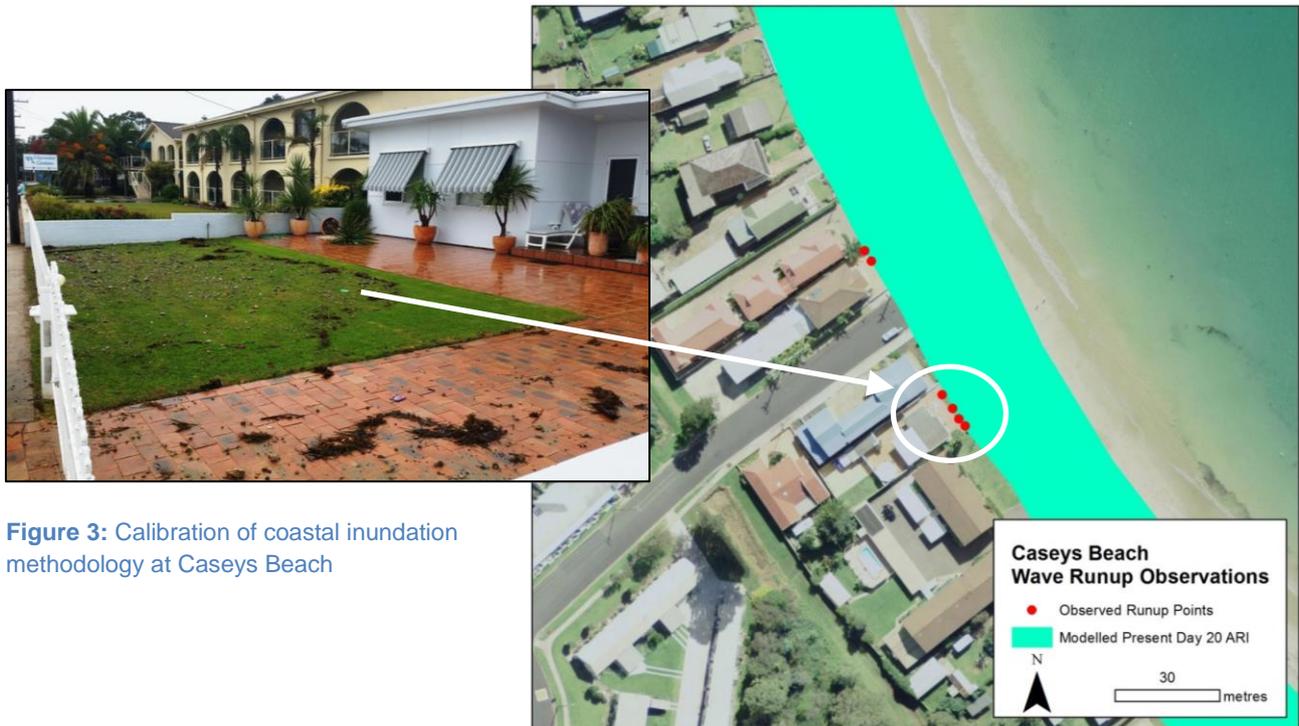
Figure 3: Calibration of coastal inundation methodology at Caseys Beach

WRL's coastal engineers had previously surveyed the high-water marks associated with wave action in the study area on a sandy beach (Malua Bay) after a major storm in August 1986, and over a seawall (Caseys Beach) after the June 2016 storm (figure 3).

Coastal inundation modelling in this assessment was calibrated against these field measurements of debris

lines indicating the maximum wave runup distance and areas exposed to wave overtopping.
