**Project Partner:** [OceanWatch Australia](#)  
**Year:** 2015  
**Project Reference:** 2015061  
**WRL Technical Report:** Preliminary Testing of Oyster Shell Filled Bags (2015/20)

A new technique has been proposed to reduce intertidal riverbank erosion and encourage oyster reef restoration across Australia. This technique involves the use of seeded oyster shells in coir (coconut fibre) bags. Utilising organic materials, [the method is being trialed at a number of waterway sites in Sydney](#). This pilot project aims to reduce foreshore erosion from wind waves and boat waves. Their secondary purpose is to create fish habitat. These units have the potential to become an alternative to traditional coastal protection structures by promoting the restoration of living oyster reefs and the multitude of ecosystem services these provide.

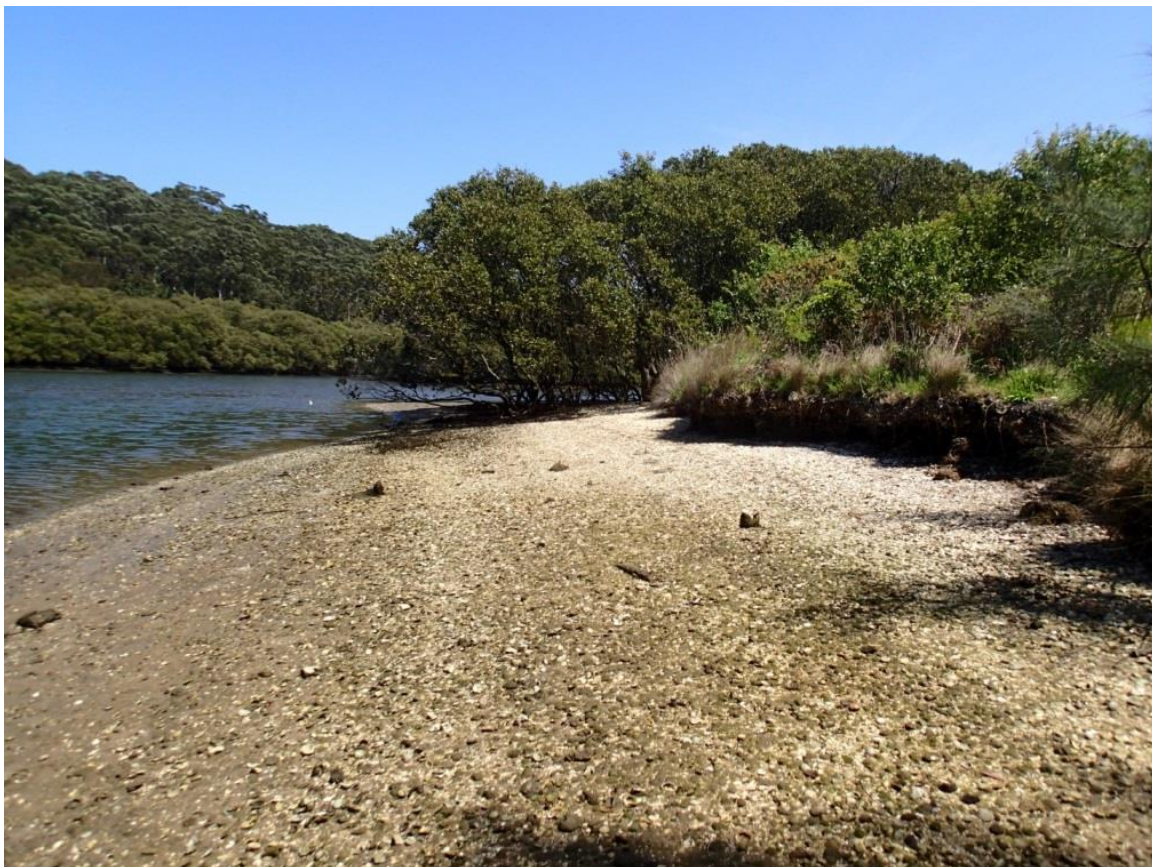
Figure 1: Example Proposed Field Site Experiencing Bank Erosion for Oyster Shell Filled Bag Structure

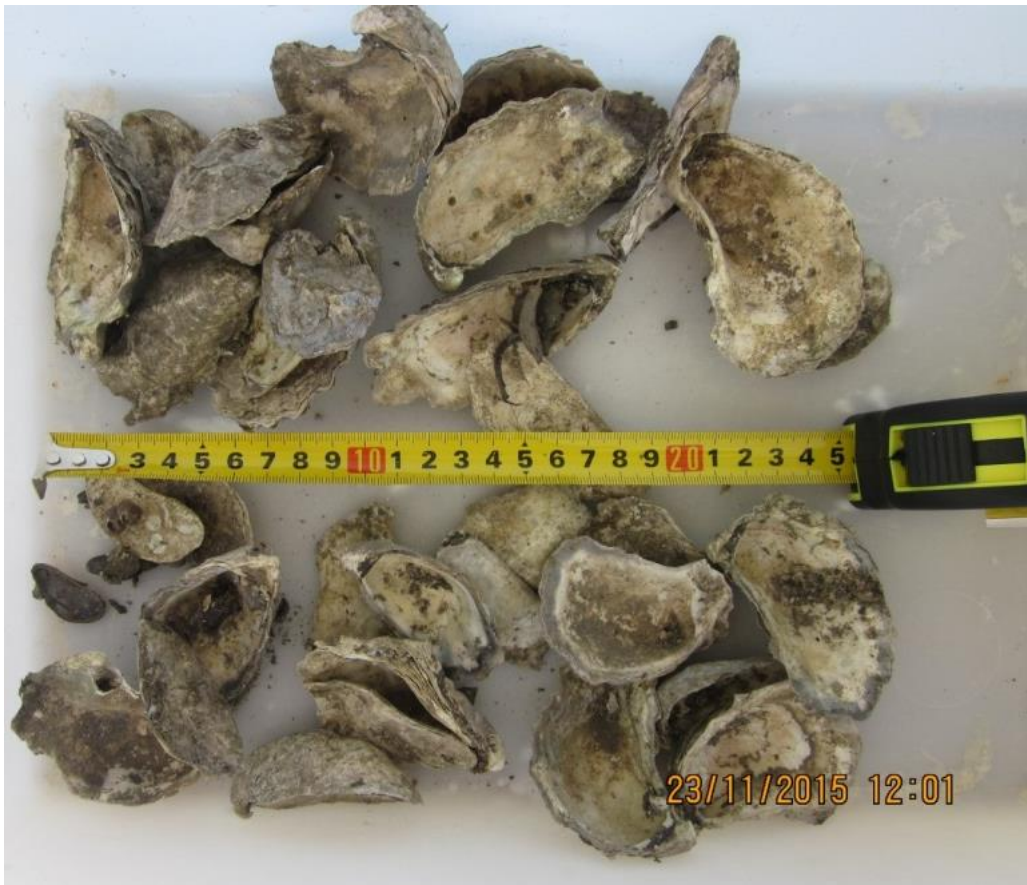
Figure 2: Sample Oyster Shells

Wave flume tests of this novel coastal erosion solution were undertaken at full scale (i.e. a length scale of 1:1) in the 3 m wave flume at WRL. The objectives of the physical modelling study were to assess the stability and wave attenuation of this type of coastal protection structure under a variety of water level and wave attack scenarios. Oyster shells to fill the bags were a mix of Sydney rock oyster (*Saccostrea glomerata*) and Pacific oyster (*Crassostrea gigas*) shells obtained from oyster farmers in Port Stephens (Figure 2). These empty shells were free of oyster tissue and subject to biosecurity treatment prior to transport from Port Stephens.

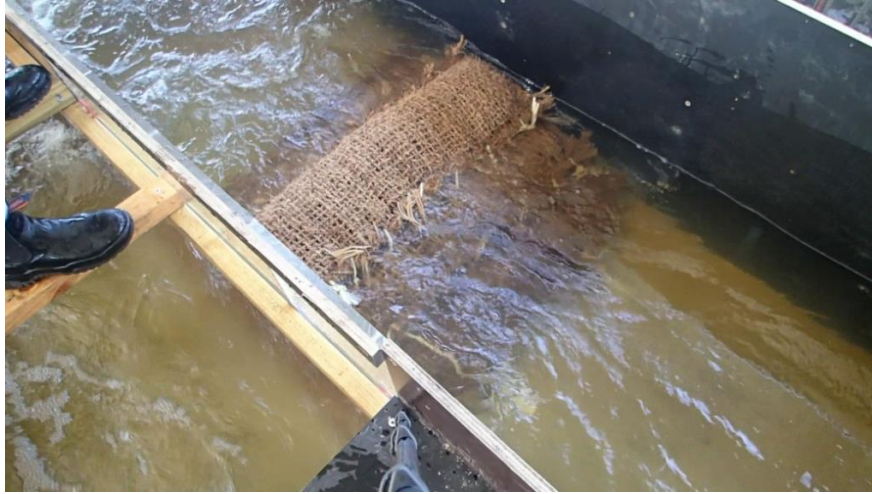
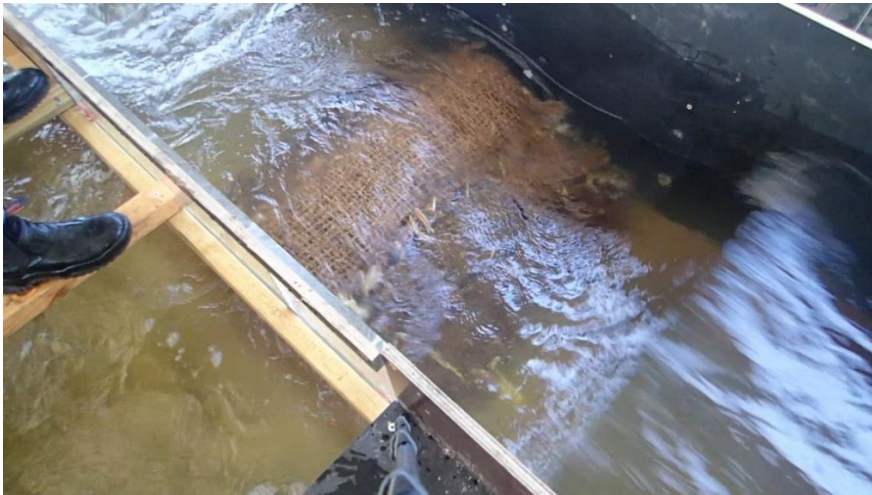
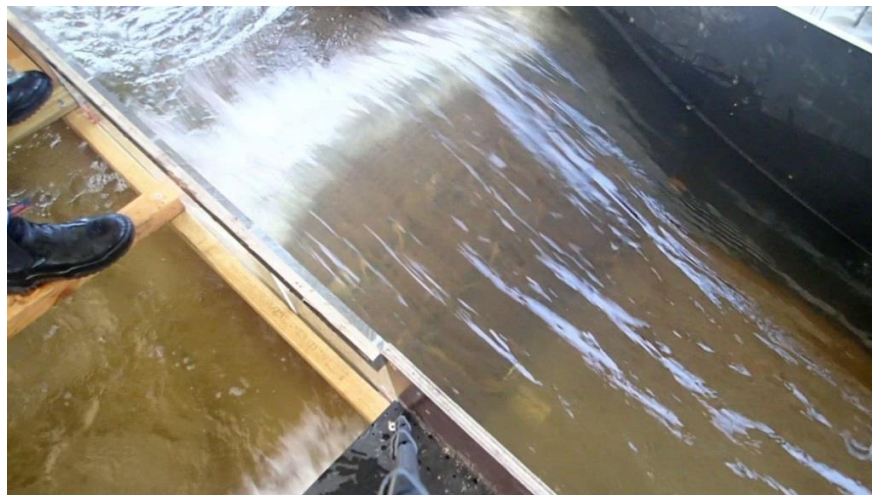
Figure 3: Oyster Shell Filled Bags Under Wave Attack in WRL's 3 m Wave Flume  
Note – Wave are Travelling from Right to Left

Various combinations of wave height, wave period (both monochromatic and irregular) and water level conditions were tested against combinations of three oyster shell filled bag arrangements (Figure 3). For the first phase of testing, the oyster shell filled bags were not anchored to the bed and were not secured together so as to identify their behaviour and identify threshold wave heights for bag movement. Wave transmission through/over the structure was also measured to infer the likely reduction in foreshore erosion with the oyster shell filled bags in place. During the second phase, the oyster shell filled bags were anchored to the bed, secured together and their movement while tethered together was monitored.

The investigation yielded several important conclusions. The threshold wave heights at which rocking of the bags were initiated for each bag arrangement, water depth and wave period combination were documented. The rope seams and the coir bags did not break during the preliminary physical modelling program, however, the limited duration of model tests is not a true indicator of long term durability. Two key stress points were identified for monitoring of biological decay and/or fatigue failure during pilot field trials of the oyster shell filled bags. Recommendations were given as to the cross-shore position of the oyster shell bags on the inter-tidal profile to replicate conditions experienced in the 3 m wave flume. As a direct result of the presence of an oyster shell filled bag structure, some existing wave-driven foreshore erosion processes are expected to be attenuated immediately landward of the structure.
